**Statia**  
Estate Guyeau

Review of the Spatial Development Plan  
St. Eustatius

project number:  
44000957.20180112

# An Archaeological Exploratory Field Investigation of Guyeau, St. Eustatius, Caribbean Netherlands

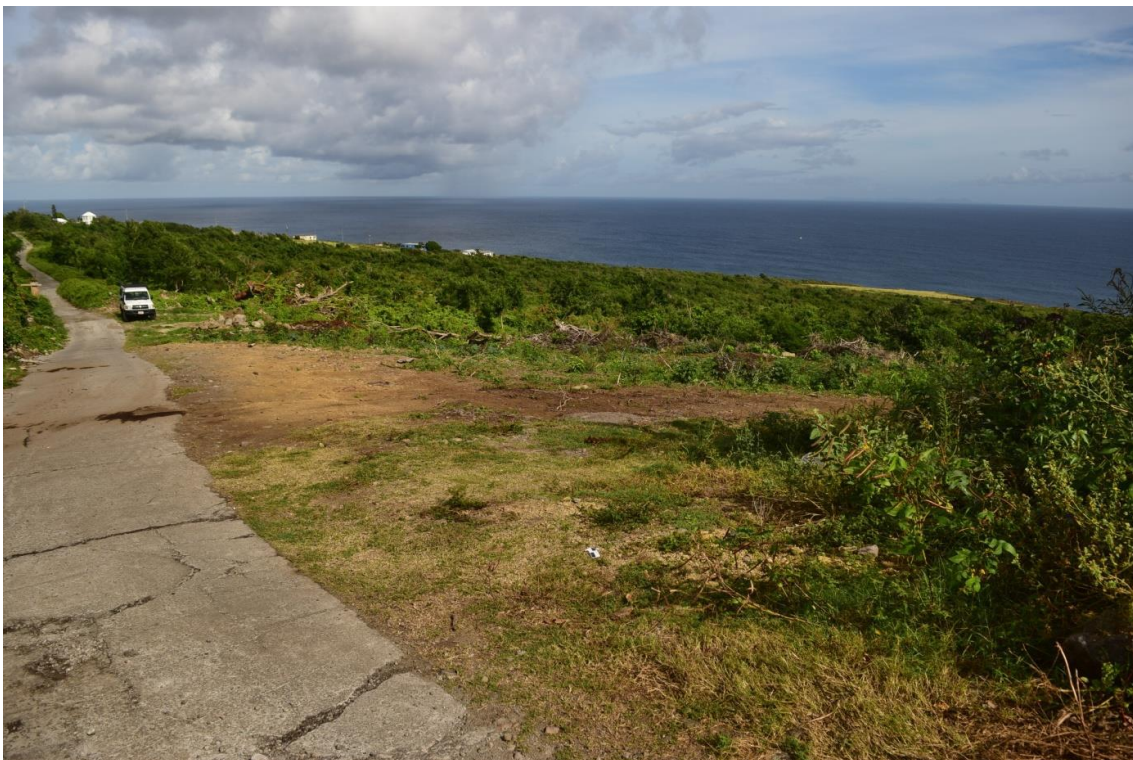
On the northeast side of the island of St. Eustatius lies the former plantation of Estate Guyeau. The site is located about three kilometres east of Oranjestad and the island's international airport. On the south side Estate Guyeau is bordered by a narrow access road. The coastline of the Compagnie Bay forms the northern boundary. The site covers an area of 179,000 m<sup>2</sup> with a coastline of 318 metres. It is undeveloped in its current situation.

*Figure 2.1: Current situation planning area ( source: SECAR)*

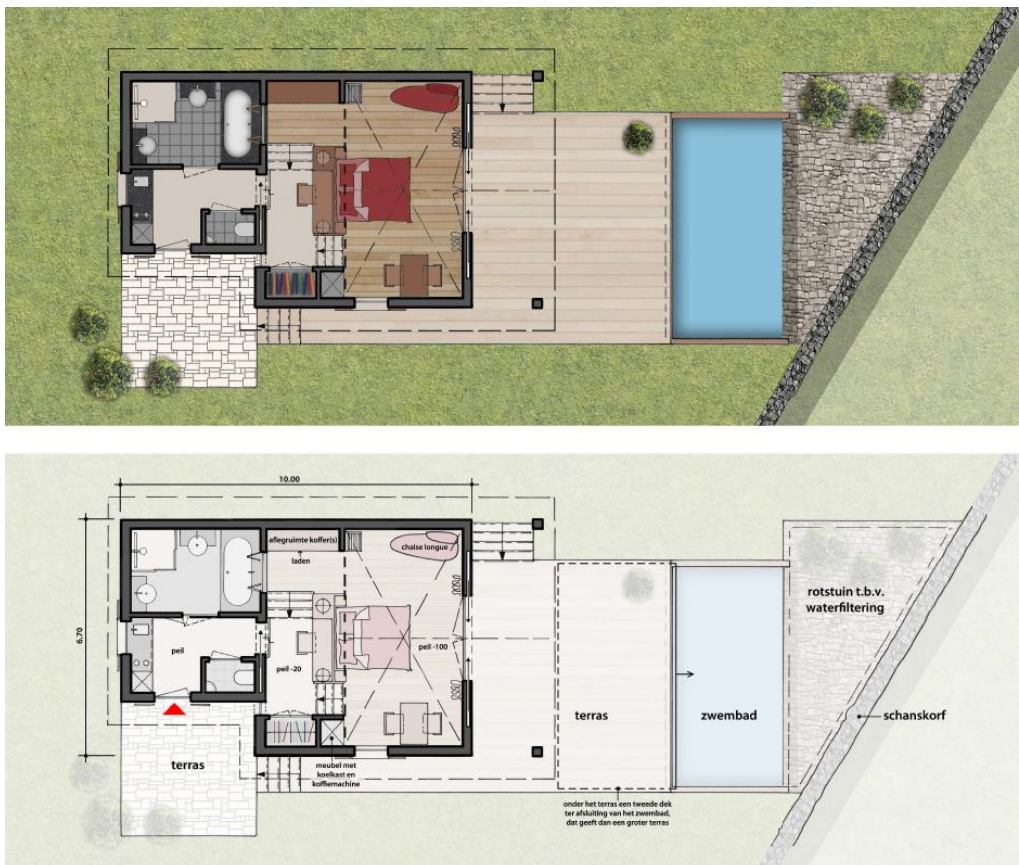
Central to the area of the villas, a hotel complex is realised. As a departure from hotel Petit Guyeau, this complex consists of separate cabins. Each cabin has an area of approximately 65 m<sup>2</sup>. They are erected in one building floor and covered with a sloping roof. Just as the villas mentioned earlier in this report, these cabins are executed in the Caribbean style. Due to their limited height, the cabins do not obstruct the view of the villas situated on slightly higher ground.

The cabins are luxurious. In addition to a spacious bedroom, they also have their own pantry and separate bathroom. At the front there is a veranda overlooking the sea. As an option, the veranda can open onto a small pool and a rock garden.

Figure 2.3: Artist impression cabin Petit Guyeau (source: Estate Guyeau)

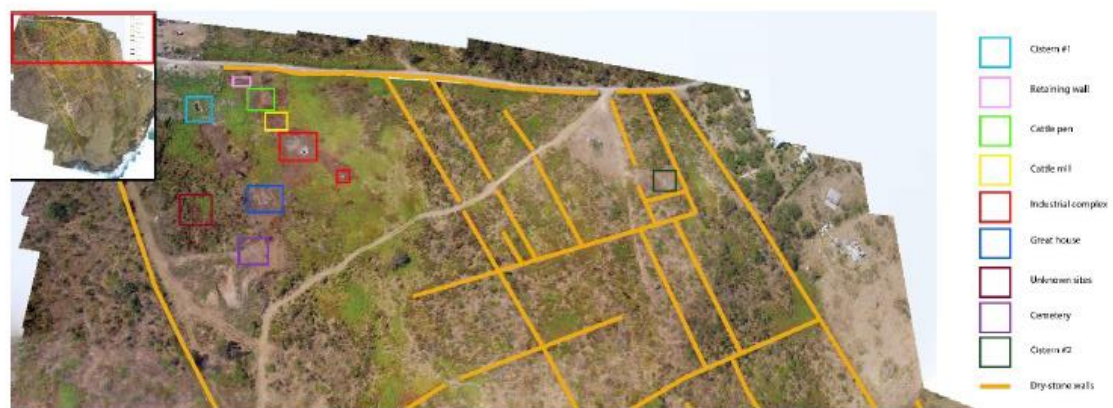
Archaeological sites are also present in the plan area (see illustration on the next page). Most of these are clustered in a small area near the road. These archaeological remains include a relatively small sugar plantation. This sugar plantation includes an industrial complex, cattle mill, cattle farm, main house, cemetery, undesignated locations and the newly discovered cistern. There are two recommendations for the archaeological remains that are part of this sugar plantation. First, all the sites can be included in the plans and (partially) restored or maintained on site. Second, if inclusion and (partial) restoration is not possible and one (or more) locations have to be destroyed, further research will be carried out in the form of archaeological excavations to maintain the location off site.

Figure 4.2: Aerial map of Guyeau with the observed archaeological sites (source: SECAR)

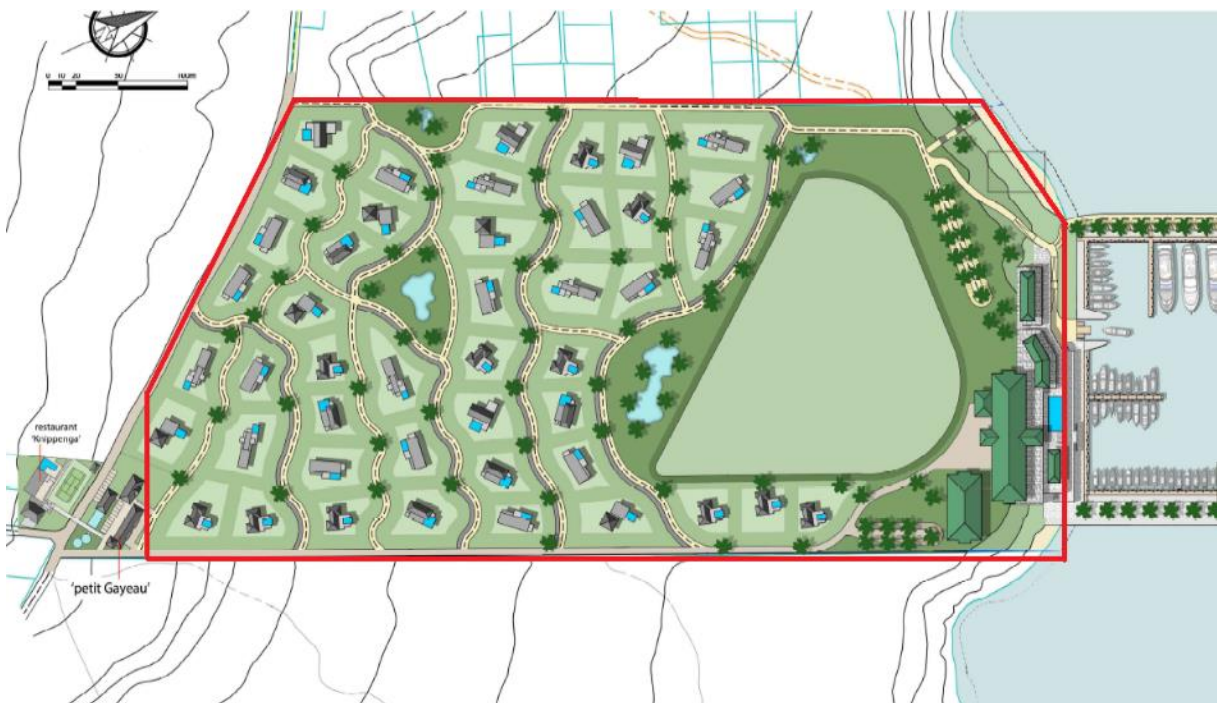
The reason for this research is that development is going to take place in the area. The plot of land that is discussed in this research is called Guyeau. Robert Proper plans to construct several luxurious bungalow villas on this plot of land (Fig. 1).

Figure 1: The planned development for the Guyeau property. The area that will be discussed in this report is outlined in red  
Source: Robert Proper.

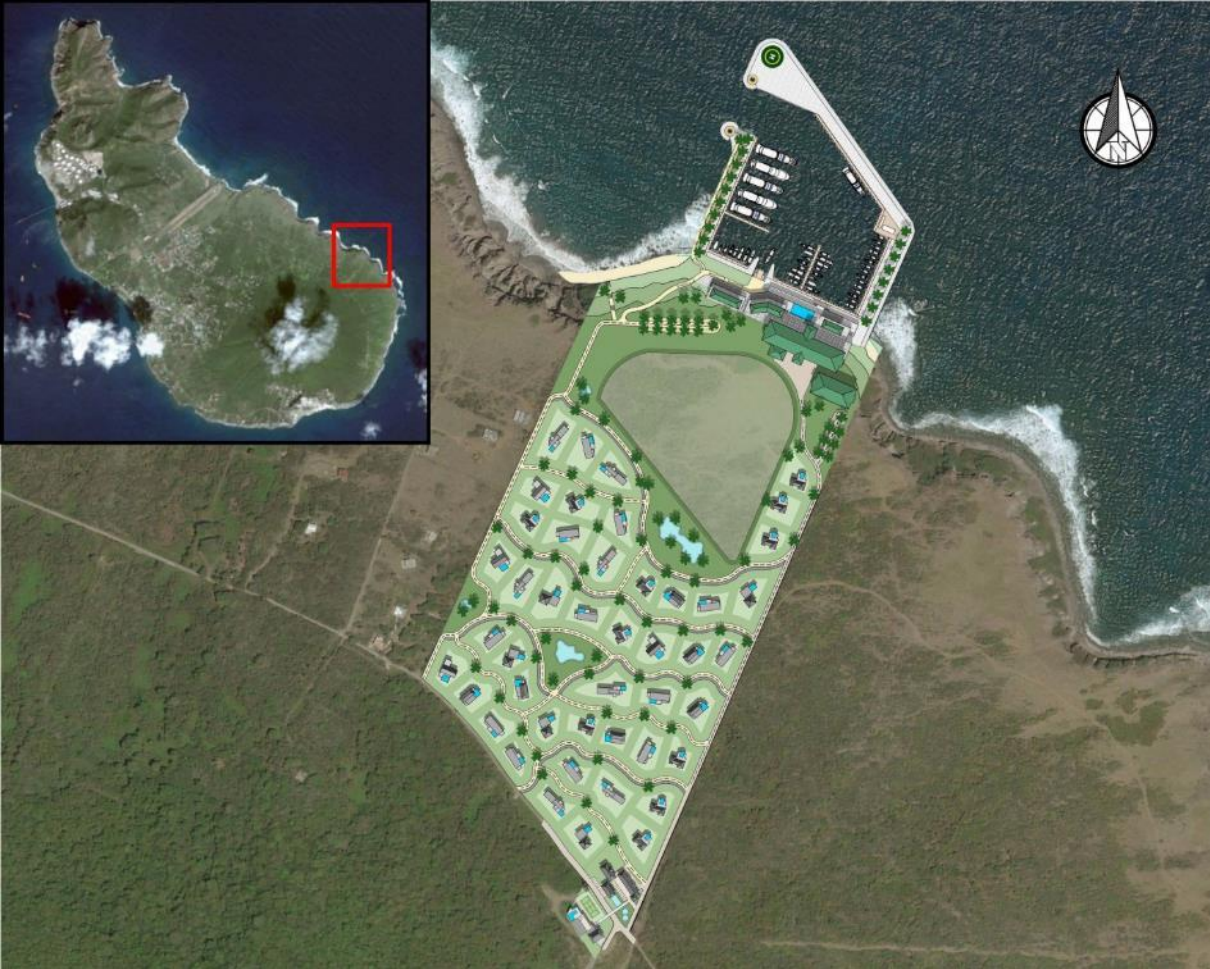
The planned area for development is a piece of land on the eastern side of St. Eustatius, across the street from Knippenga Estate (Fig. 2). The planned area for construction that is discussed in this report is approximately 700 meters long and 325 meters wide (Fig. 2). This is the complete terrestrial area of the property that is up for development.

Figure 2: The piece of property that is up for the development. The hotel is in the bottom right corner on the northern side of the street. Source: Robert Proper.

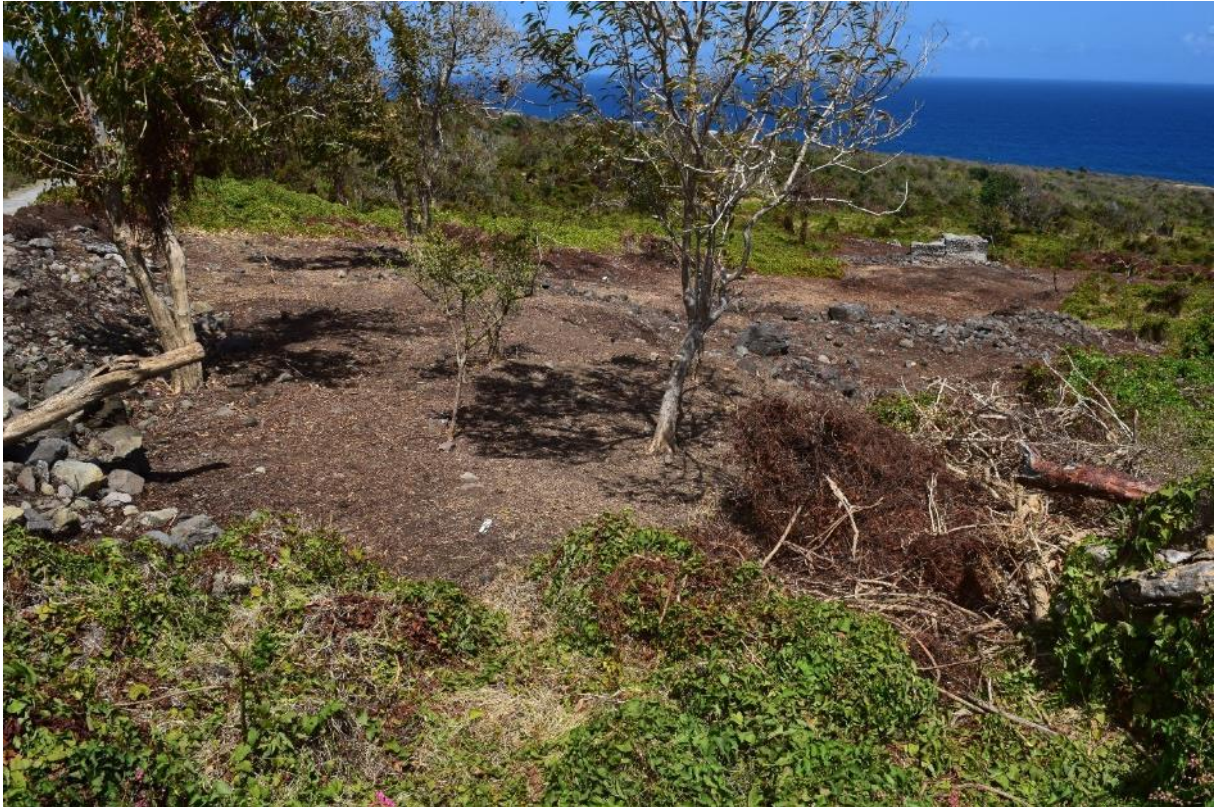
Select areas on the property were cleared by Paradise Landscaping (Fig. 5). They used chainsaws, machetes and weedwhackers to remove the vegetation in the area. An archaeologist from SECAR was present three times a day to give instructions, check the progress and to ensure that no archaeological remains were destroyed. During the clearing of the area, more archaeological remains have been observed. A boiling house, molasses vat, cane juice clarifier basin, great house, cemetery,

Figure 5: Part of the cleared area, seen from the stone pile wall near the road (Photo: SECAR Staff).

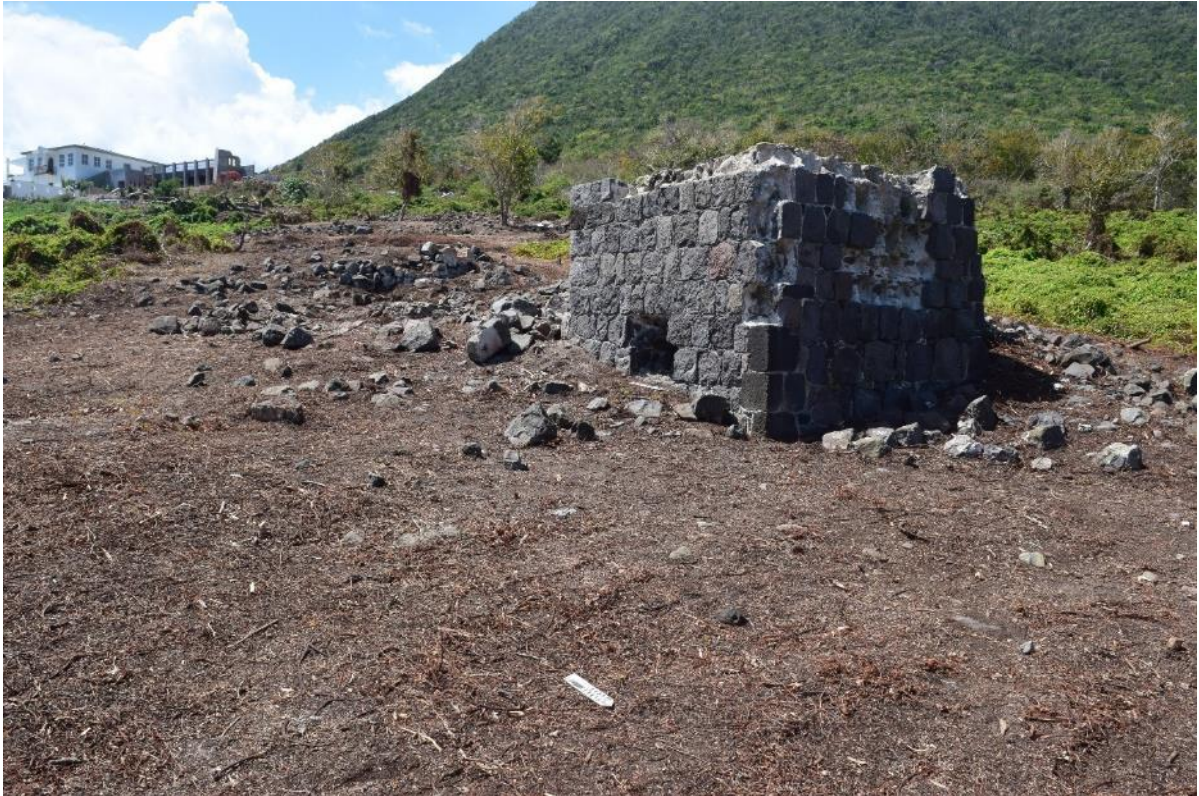
Figure 8: Overview of the industrial complex (Photo: SECAR Staff).

The industrial complex consists of a molasses vat (Fig. 11), a cane juice clarifier basin (Fig. 13), boiling house(s) (Fig. 10; Fig. 14 – Fig. 17), a presumable rum distillery (Fig. 18), an unknown structure (Fig. 19), a cattle mill (Fig. 20 and 21) and a cattle pen (Fig. 22 and 23). A presumable rum distillery, because it could very well be a retaining wall that keeps the plateau, on which the cattle mill is, from eroding. A rum distillery, however, would explain the large molasses vat on the property (Fig. 11). Still, on other plantations on Statia, a boiling house would be the closest to the cattle mill. Further excavation is needed to determine its true purpose.

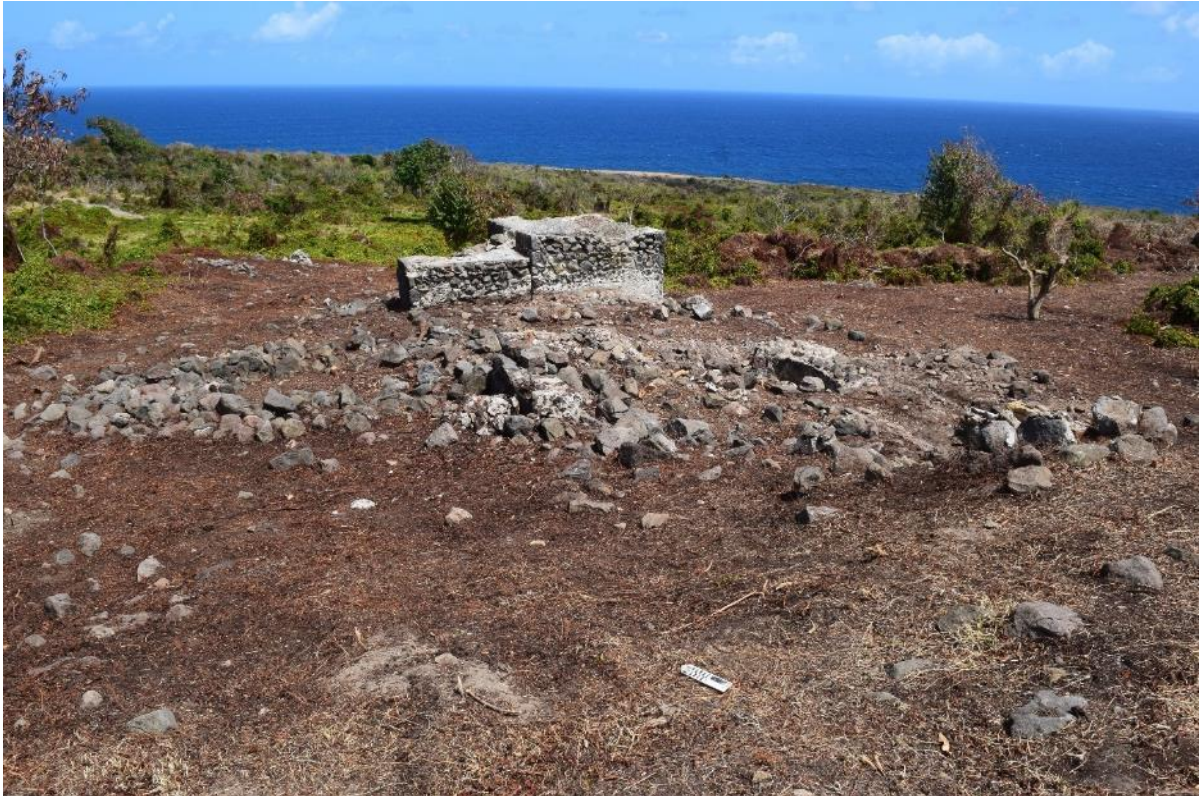
Figure 9: Overview of the industrial complex (Photo: SECAR Staff).

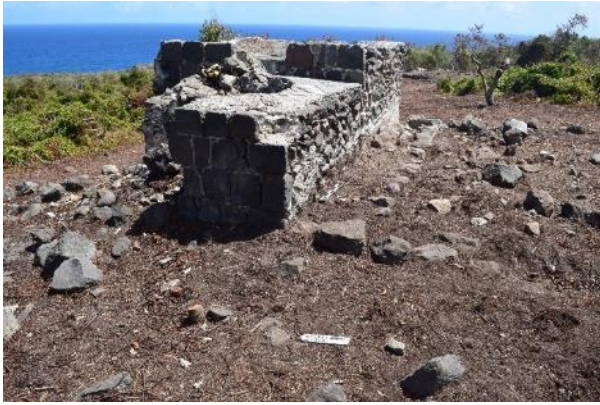
Figures 10 and 11: A structure that used to contain a kettle for boiling cane juice and behind it a molasses vat (Photos: SECAR Staff).

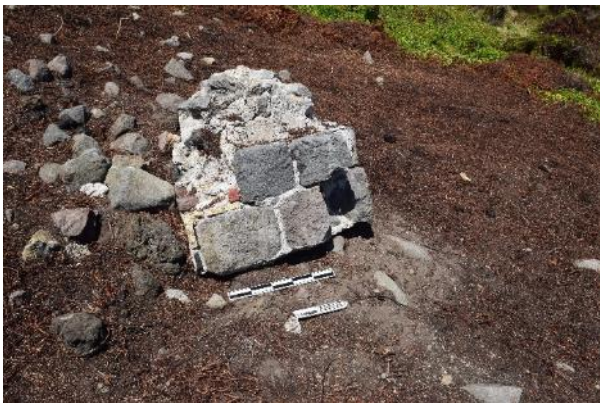
Figure 12: Possibly the corner that is missing from the structure that can be seen in figure 6. This corner can be found downhill from the molasses vat in the northwestern direction (Photo: SECAR Staff).

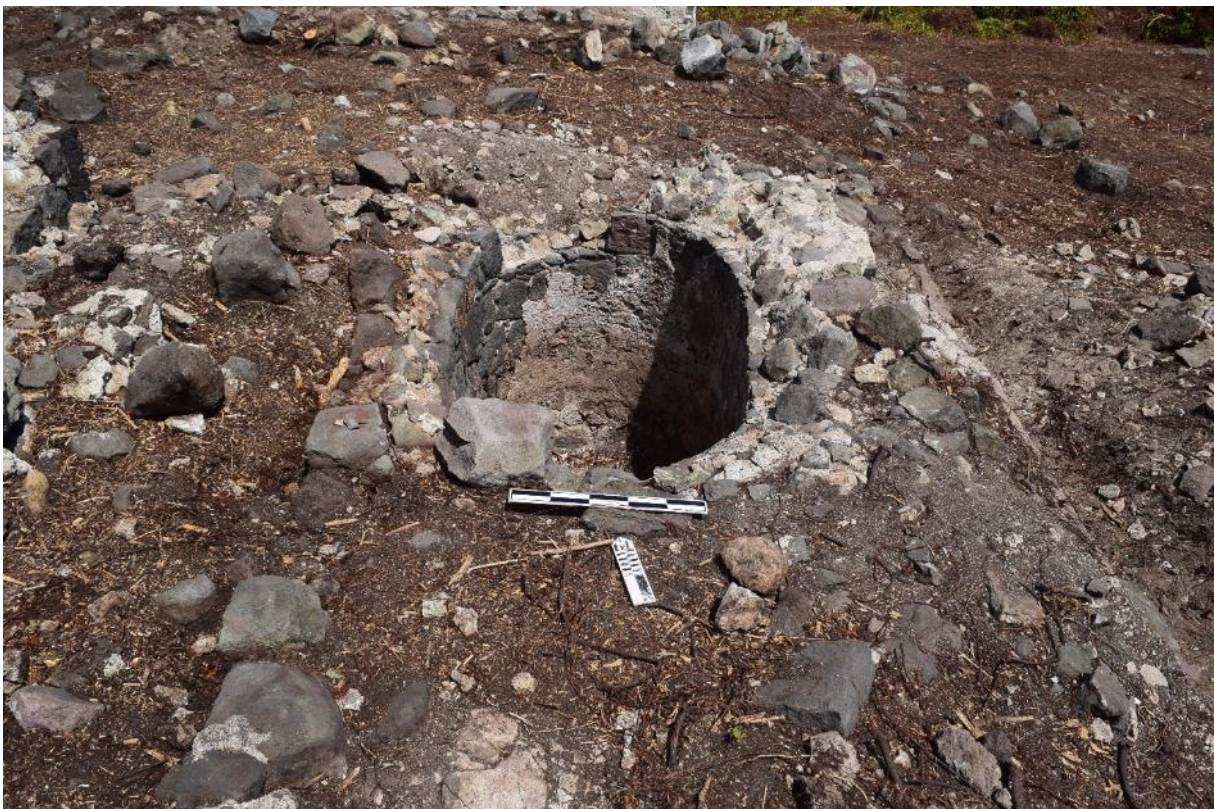
Figure 13: The cane juice clarifier basin that was used to collect the juice after crushing the sugar cane.

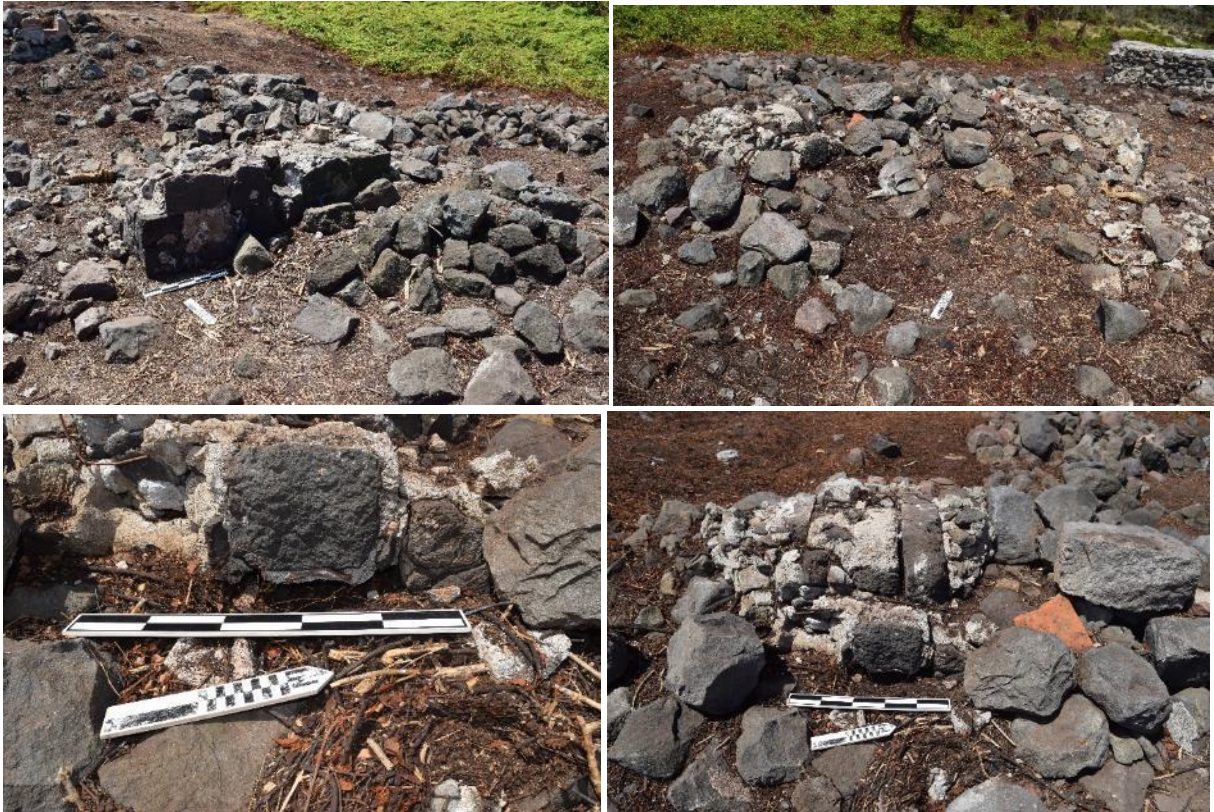
Figure 14 (clockwise starting in the top left corner): The boiling house seen from the NNE. Figure 15: The boiling house seen from the SSE. Figure 16: The inside of the furnace. Figure 17: Close-up of the arch of the furnace (Photos: SECAR Staff).

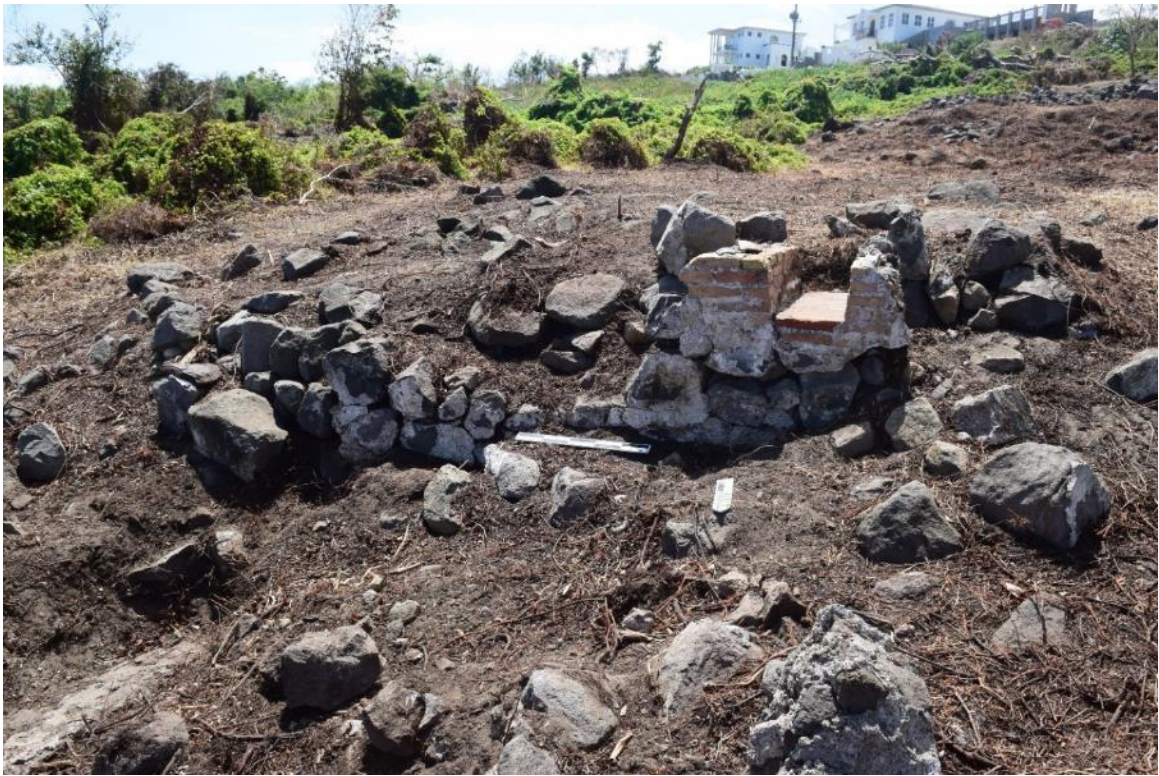
Figure 18: The presumable rum distillery (Photo: SECAR Staff).

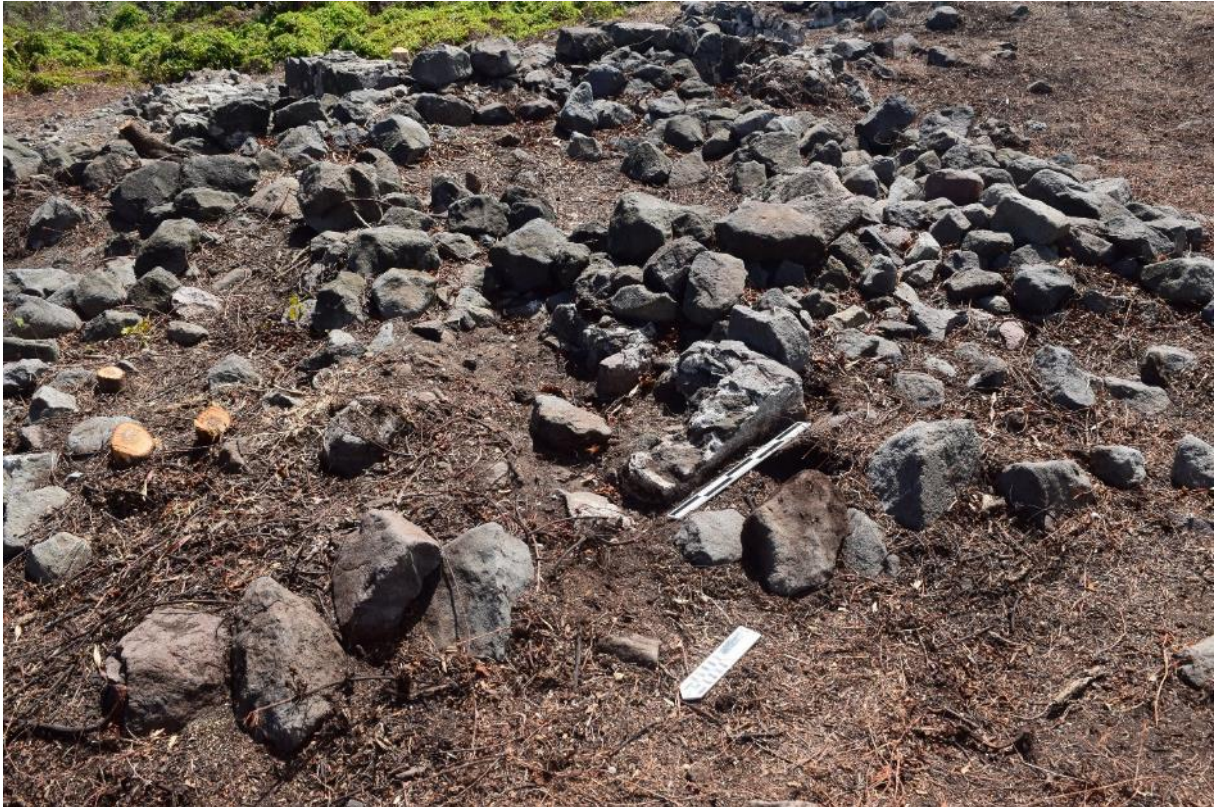
Figure 19: Unknown structure northwest of the boiling house (Photo: SECAR Staff).

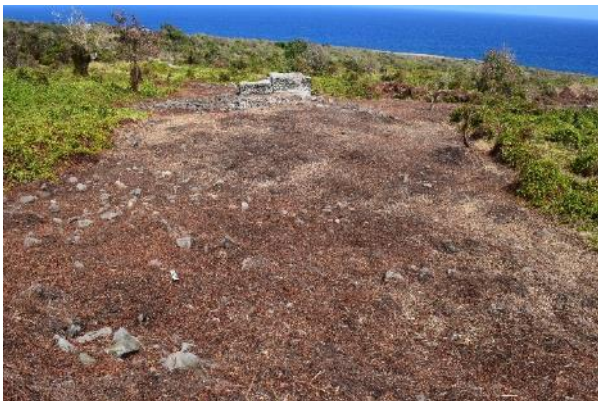
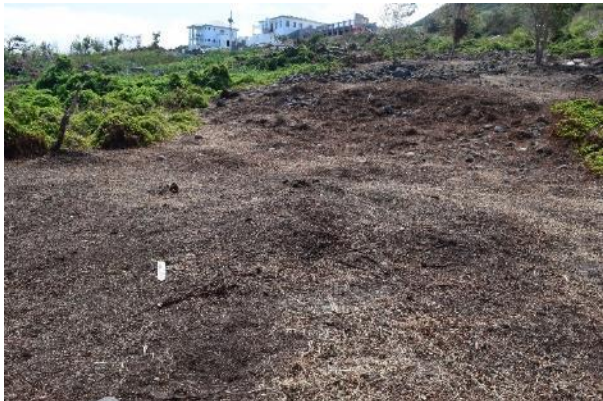
Figures 20 and 21: Plateau on which the cattle mill used to be (Photos: SECAR Staff).

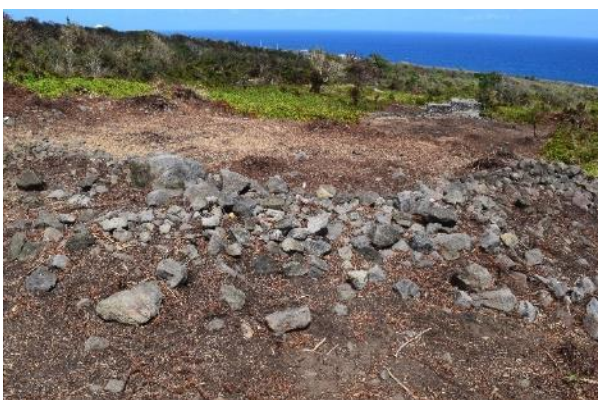
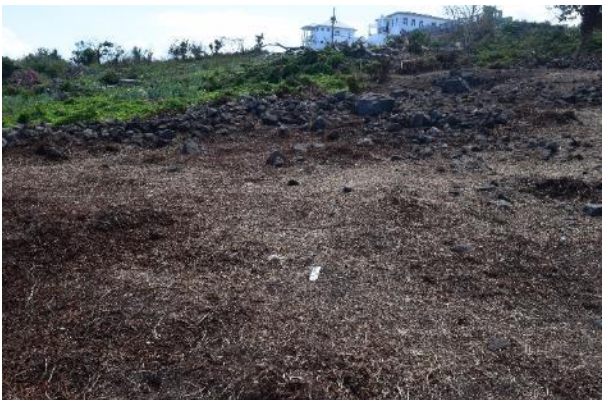
Figures 22 and 23: Plateau that is surrounded by rocks, presumably a cattle pen (Photos: SECAR Staff).

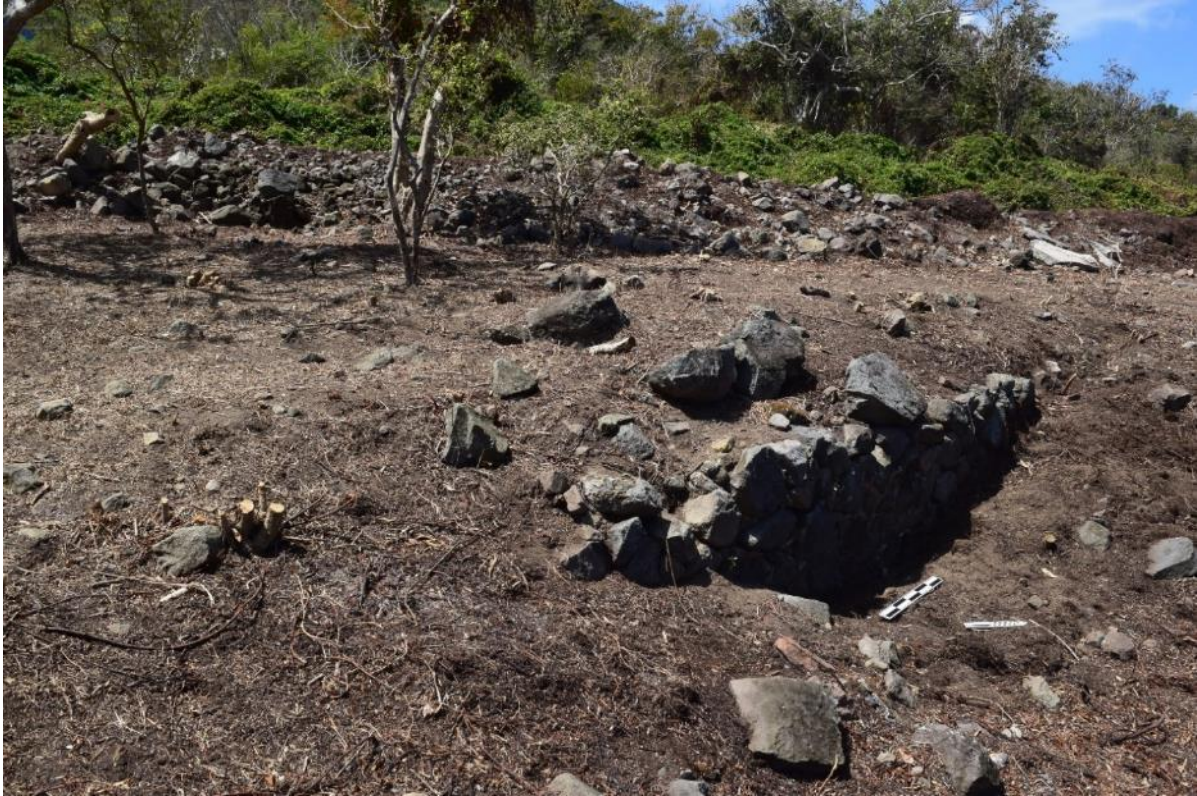
Figure 24: Retaining wall and plateau near the road (Photo: SECAR Staff).

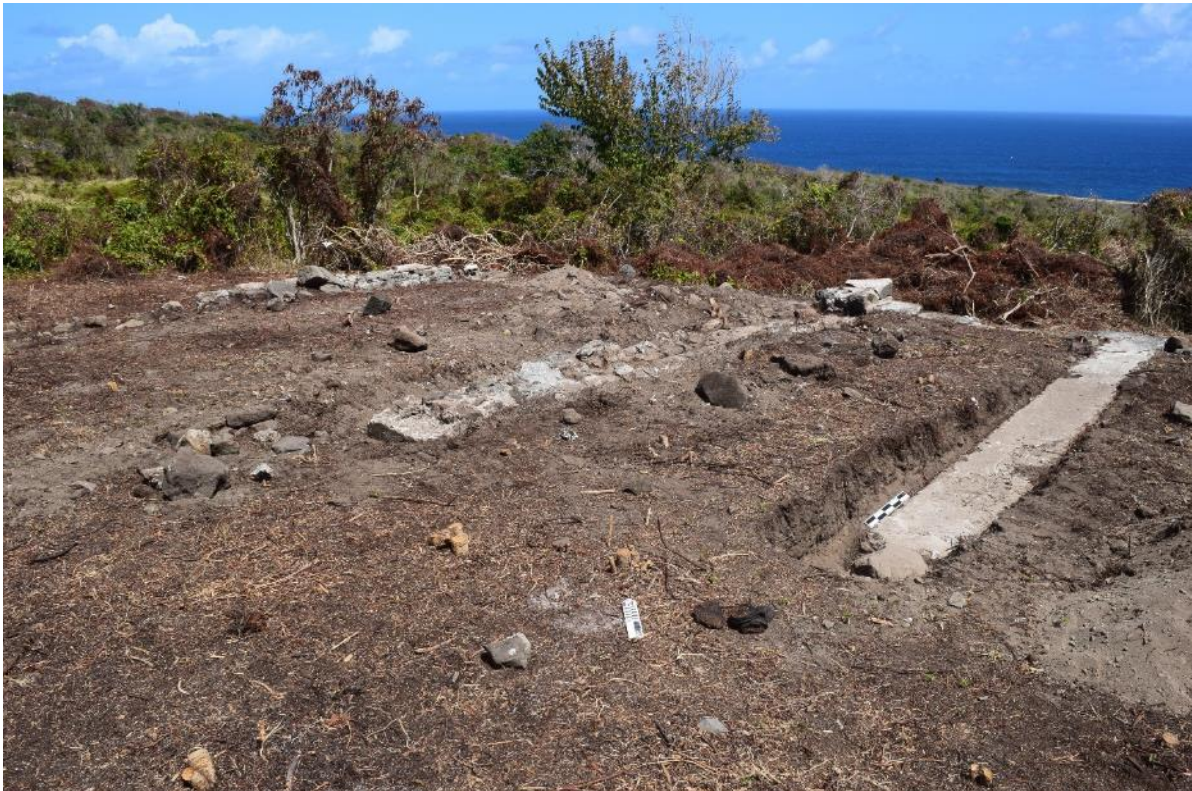
Figure 25: Foundation of the great house (Photo: SECAR Staff).

The foundation of the great house (Fig. 25 and 26). There does not seem to be a wall on the southwestern side of the house.

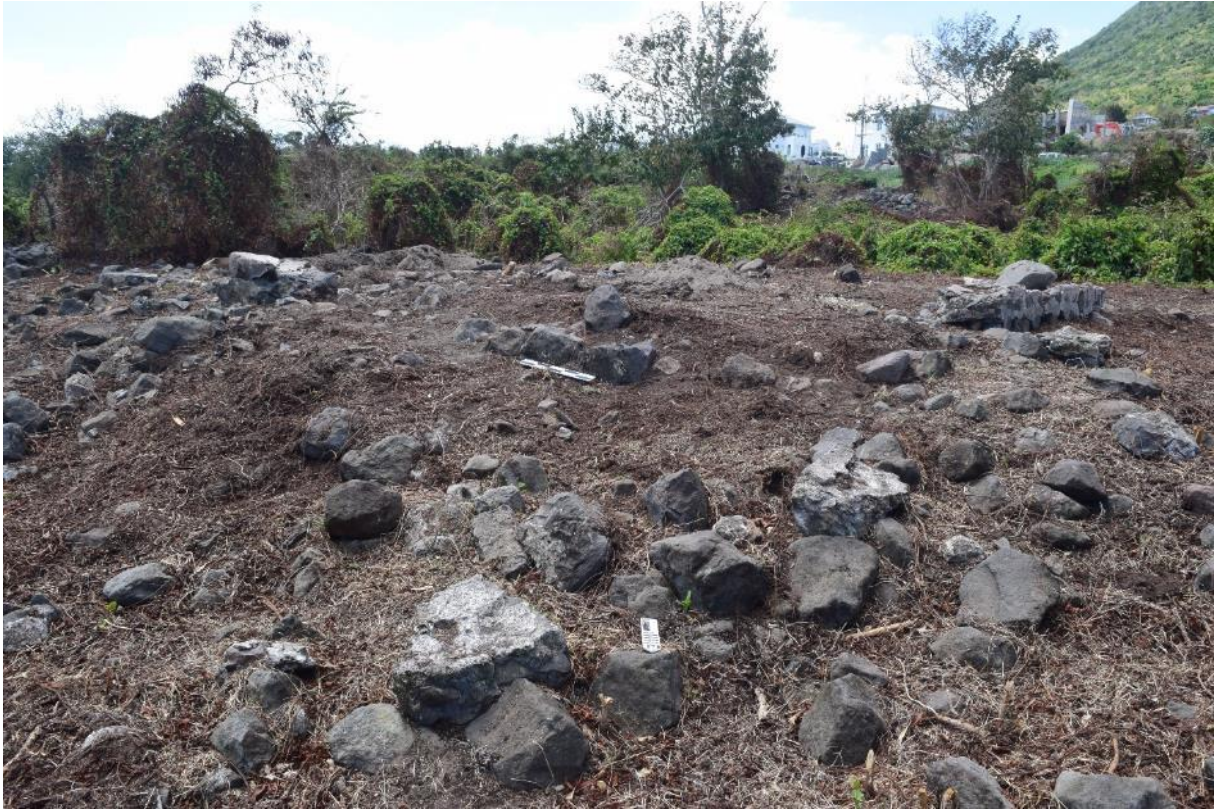
Figure 26: Foundation of the possible great house (Photo: SECAR Staff).

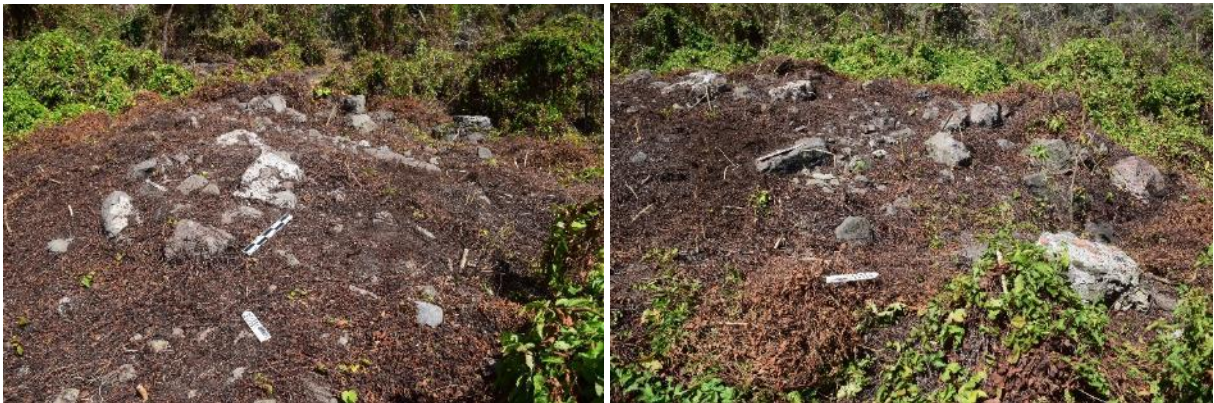
These sites can be found to the southeast of the great house (Fig. 27 and 28). A bee's nest was found near these sites, which made it very difficult to clear the area of vegetation.

Figures 27 and 28: Unknown sites (Photo: SECAR Staff).

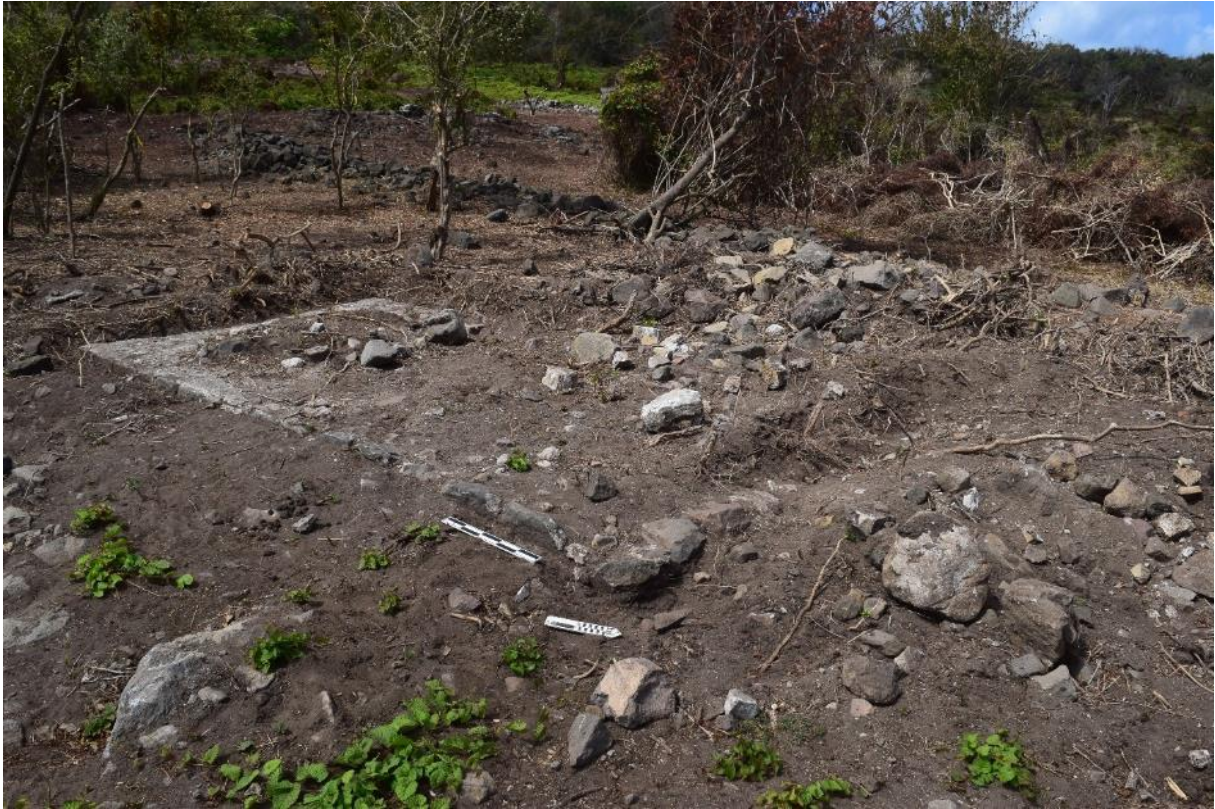
After rediscovering the cemetery, it was found to be destroyed. The tombstones are no longer there; only yellow bricks can be observed on the surface (Fig. 29 and 30). The cemetery was probably destroyed when the adjacent area was mechanically cleared prior to the start of this research. Sand has been excavated in this cleared area.

Figure 29: The destroyed cemetery; yellow bricks are scattered around. The great house and a dry-stone wall can be seen in the background (Photo: SECAR Staff).

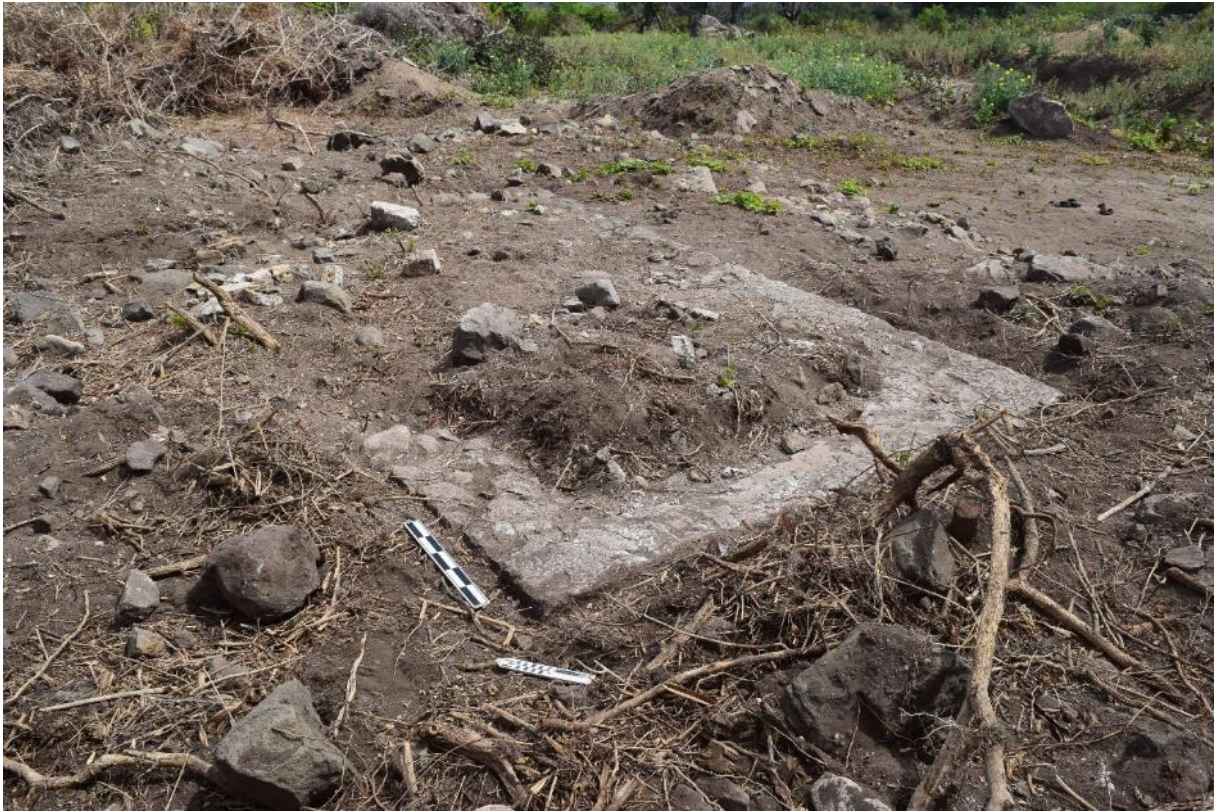
Figure 30: The cemetery; the top right corner shows the place where sand has been excavated (Photo: SECAR Staff).

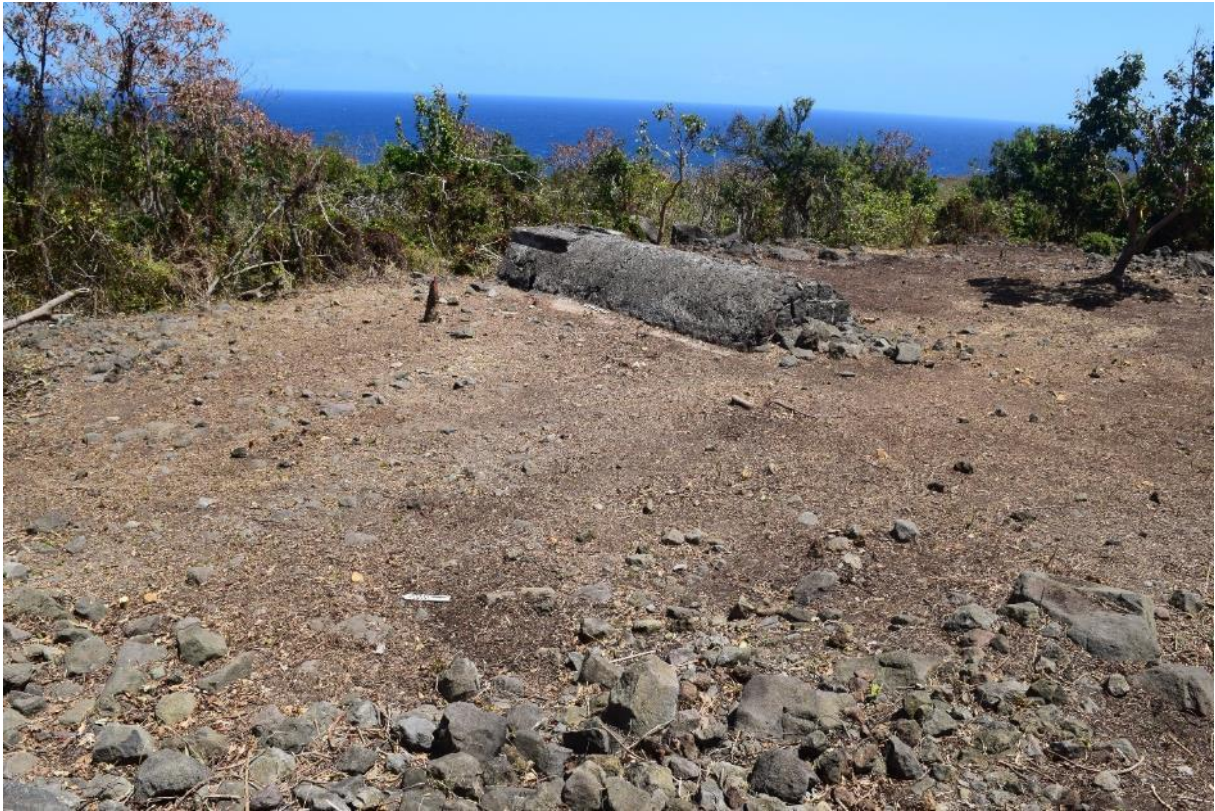
Figure 31: The cistern seen from the west (Photo: SECAR Staff).

Another cistern was found on the property (Fig. 31 – Fig. 35). The first cistern that was found is discussed in the previous report. This cistern is in a much better state with the arch still intact and there is very little rubble inside the basin.

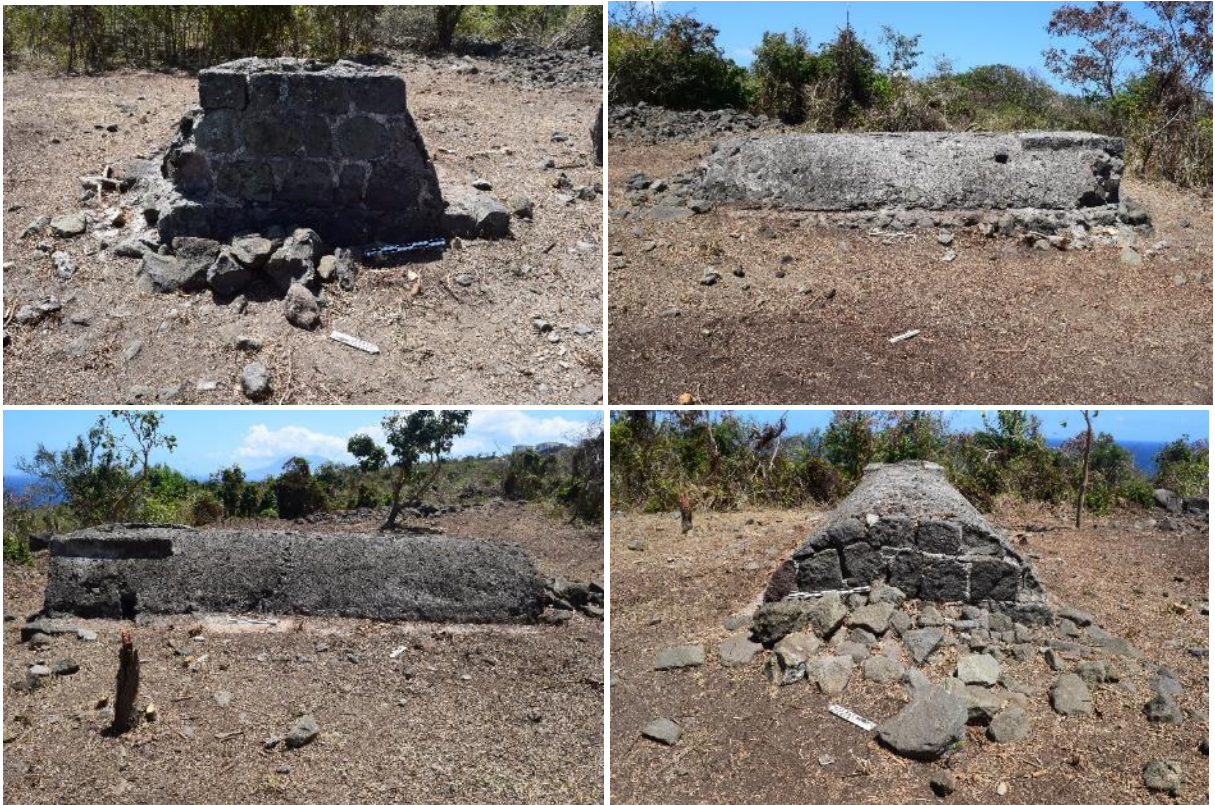
Figure 32 (clockwise starting in the top left corner): The cistern seen from the northeast. Figure 33: The cistern seen from the southeast. Figure 34: The cistern seen from the southwest. Figure 35: The cistern seen from the northwest (Photos: SECAR Staff).

The water catchment was probably on the northern side of the cistern; however, this is not visible anymore. On the other side of the cistern, a water inlet hole is placed high on the arch. This could mean that a building was close that redirected water from its roof into the cistern. After a thorough search, no remains of a building have been observed.

<b>Comments</b>
<p>This cistern has two water inlet holes. One is located near the ground and the other one is higher on the arch. The latter could have meant that it received water from the roof of a nearby building. However, no signs of any structure were observed.</p>

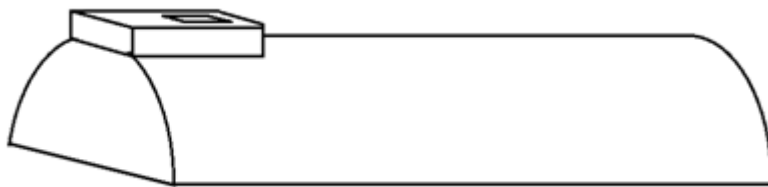
The cistern conforms to the typology made by van Keulen (2018) and can be defined as a type 3, subtype d, cistern (Fig. 36). The form that contains all the measurements and descriptions can be found in appendix 3.

Figure 36: Schematic sketch of the type 3, subtype d, cistern (Source: van Keulen 2018, 55).

The cistern is one of thirteen cisterns on St. Eustatius that are constructed in this manner. However, the cistern solely consists of hewed basalt stones. A similar cistern can be found behind the Methodist Church in Oranjestad that dates to the year 1883 (van Keulen 2018, 11). This could mean that the cistern was built in a later time-period than the plantation that is already depicted on the map of 1741.
