**Statia**  
Estate Guyeau

Review of the Spatial Development Plan  
St. Eustatius

project number:  
44000957.20180112

# An Archaeological Exploratory Field Investigation of Guyeau, St. Eustatius, Caribbean Netherlands

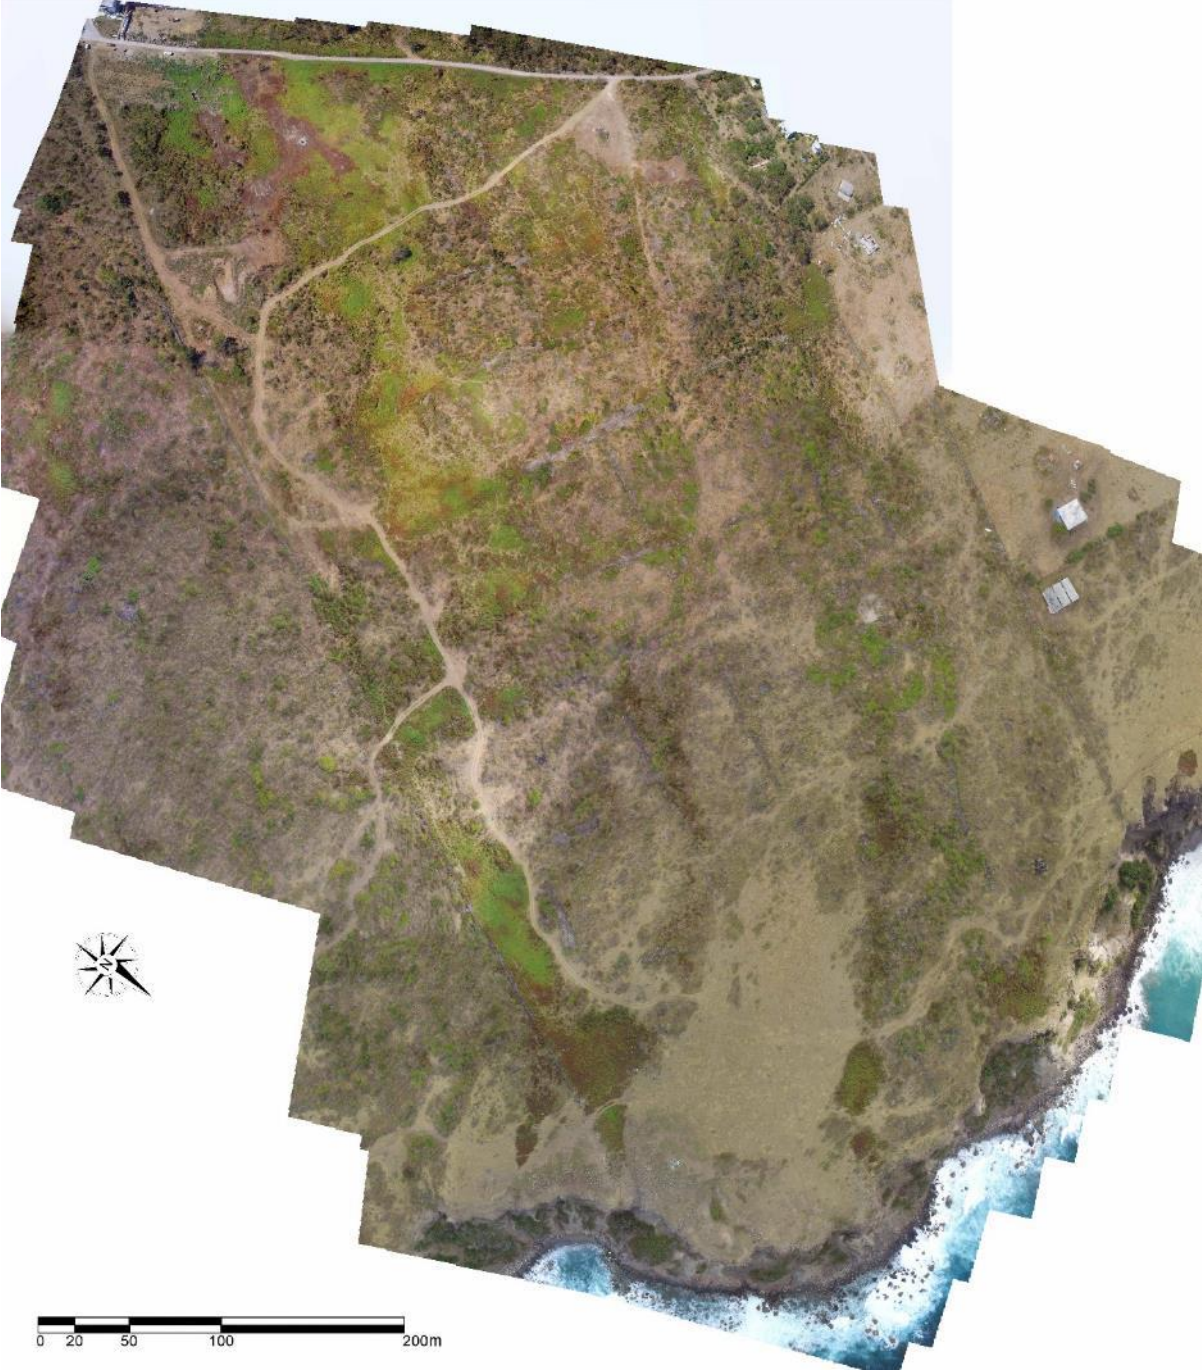
Aerial map of Guyeau

The aerial and fieldwalking survey resulted in an archaeological map (see appendix 1) that depict multiple dry-stone walls and a relatively small sugar plantation. These walls can be found all over the island and were used to mark borders (also within the property) and to redirect water. In the SECAR report no. 2017-04, the P.F. Martin map from the year 1781 shows the sugar plantation near the road. This location coincides with the findings of this report.

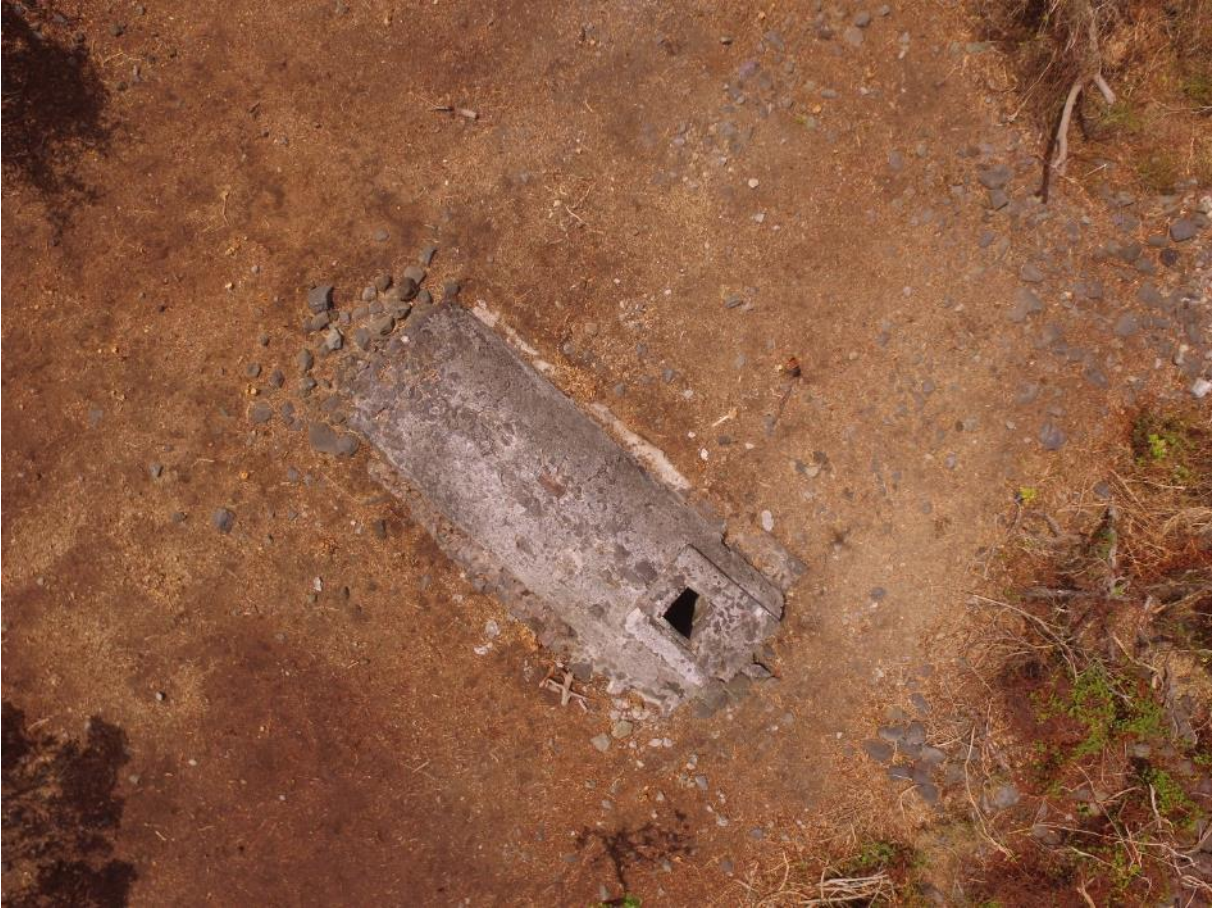
Cistern #2

Another cistern was found on the property (Fig. 31 – Fig. 35). The first cistern that was found is discussed in the previous report. This cistern is in a much better state with the arch still intact and there is very little rubble inside the basin.

The water catchment was probably on the northern side of the cistern; however, this is not visible anymore. On the other side of the cistern, a water inlet hole is placed high on the arch. This could mean that a building was close that redirected water from its roof into the cistern. After a thorough search, no remains of a building have been observed.

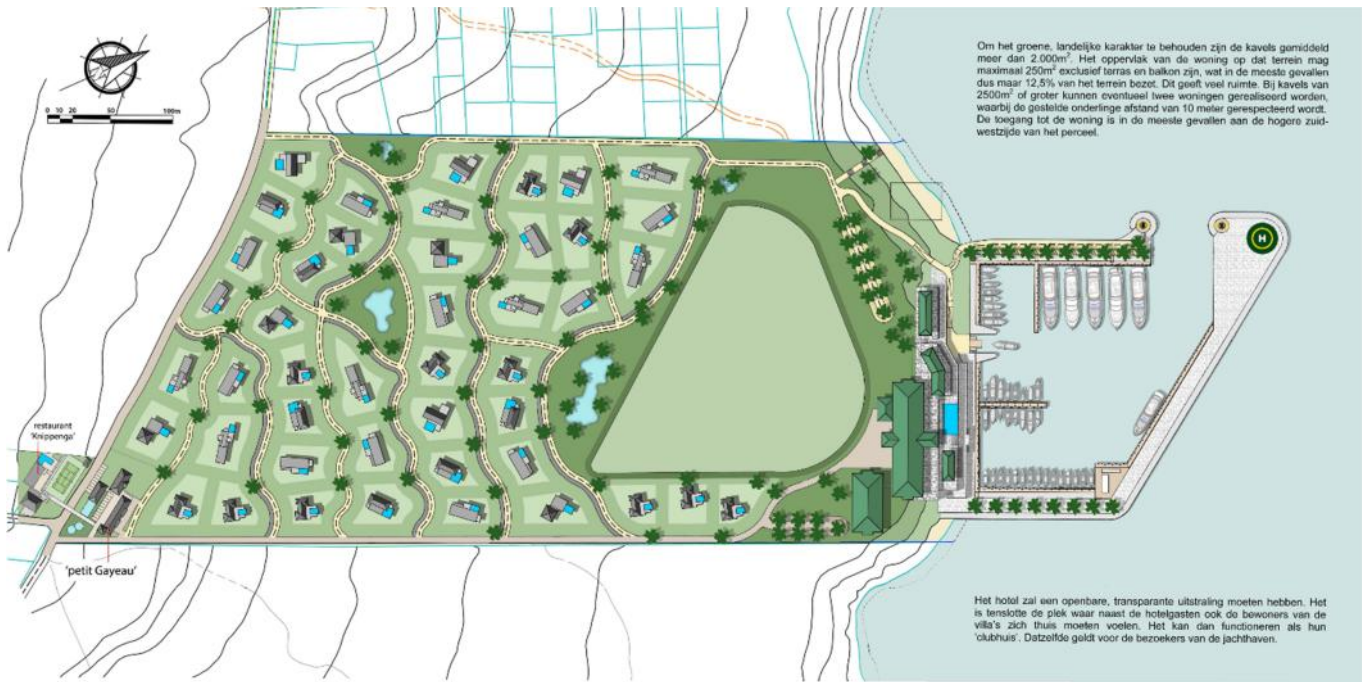
Guyeau Estate is intended to become a new development that will offer a hotel and homes, as well as a marina for yachts (Figure 2). There are 45 lots in total ranging from 1,500 to 3,000 m<sup>2</sup>. The villas will be developed into luxury vacation homes, which, in addition to being permanent homes, will also be available for rental to third parties. Individual buyers can choose to rent their villas through ‘petit Guyeau’ hotel in order to complement nearby, high quality Knippenga Estate, upon which this new development is based. Guyeau Estate will be a luxury development, ably competing with comparable successful developments on the nearby islands of St. Kitts, Nevis, and St. Barthélemy. One advantage of this development will be the presence of a quality hotel. The hotel, which initially will have 120 rooms, will not only cement St. Eustatius on the tourist map, it will also be valuable for the villas and marina. It is therefore crucial that the hotel is able to meet the demands that the type of tourists staying in similar accommodations on islands close to St. Eustatius are accustomed to. The hotel will consist of around 100 standard rooms and around 20 ‘short-stay studios’. In addition, a restaurant, brasserie, bar and shops will complement this type of quality development. In addition to the large hotel, a smaller development (petit Guyeau) will be built close to the entrance of the property. This will consist of 12 rooms and four suites, which will form the initial accommodation until the hotel by the sea is built. This can later be turned into staff quarters. All the necessary provisions such as water treatment, generators and laundry service will be situated here. The reception in petit Guyeau shall provide services for Guyeau Estate, such as porter, sales office for the project, and car rental. The marina will be suitable for larger yachts that sail within the region, thus requiring it to be of high quality and comparable with those found on other islands. Standard size will be 60 feet, however there will also be a few places for yachts two or three times that length. The marina accommodation will be integrated into the hotel building and will also include a helipad (Figure 2).

Figure 2. Overview of intended development at the Guyeau property (PVB Achitects, 2017).
