Rapid Ecological Assessment

Contractors' Work Camp, St. Eustatius

Hannah Madden M.Sc., Ecological Professionals Foundation

Adam Mitchell B.Sc., St. Eustatius National Parks Foundation

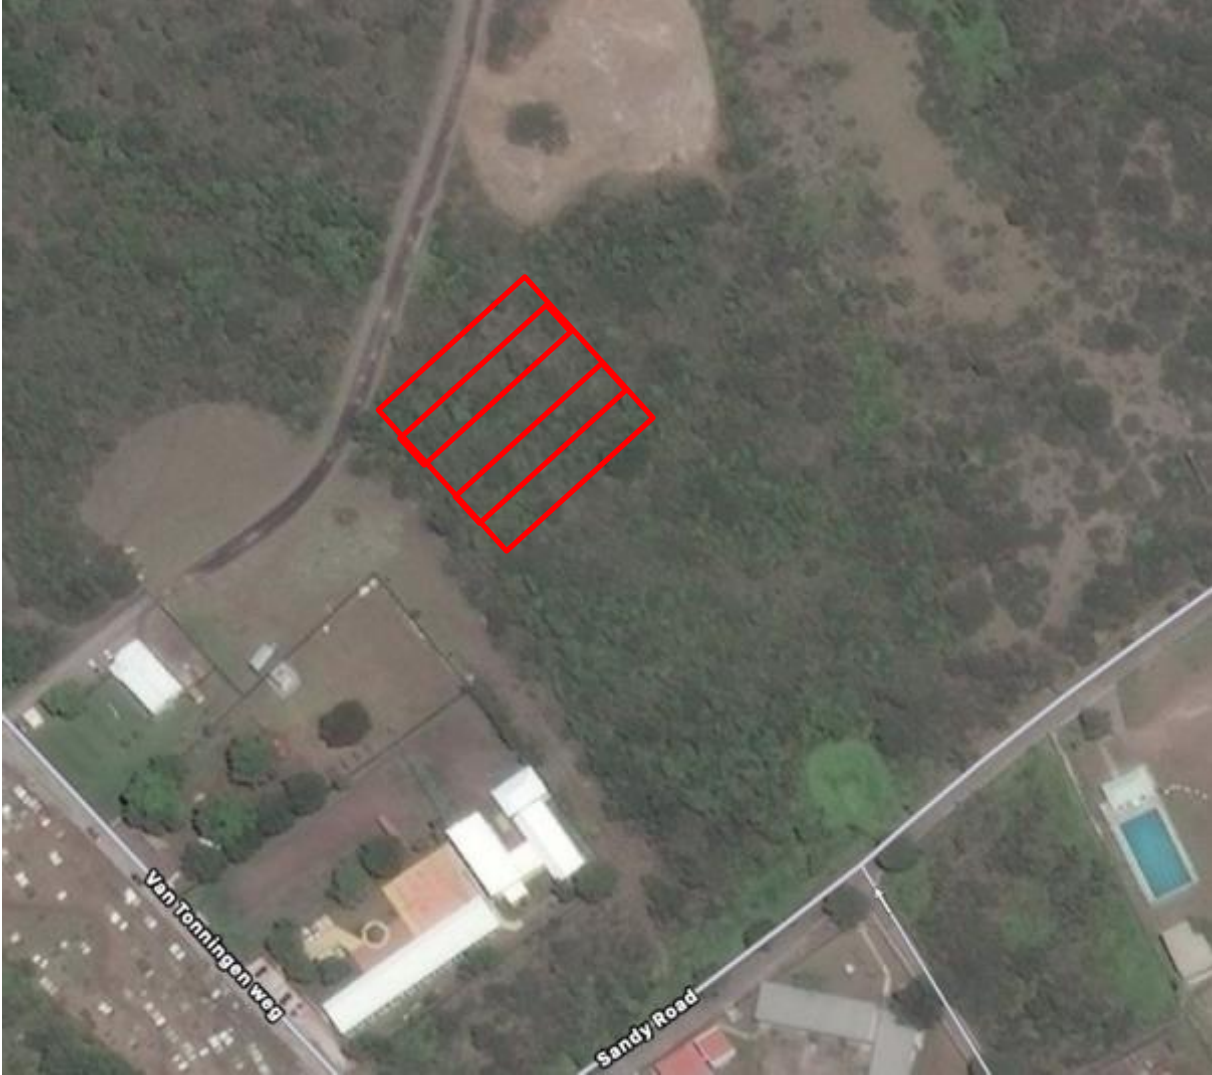
On 2 April 2020, walking transects were conducted throughout the proposed development. Six transects were conducted over the area with approximately 10 meters distance between each transect (Figure 4) Whilst conducting the transects, two team members walked simultaneously, one recording and listing species of flora observed. The second person recorded fauna species through visual and aural observations. All animals seen or heard in the close proximity of the area were recorded. In addition to the listing and recording of species

Figure 4. Overview of transects walked in the proposed Camp development area.

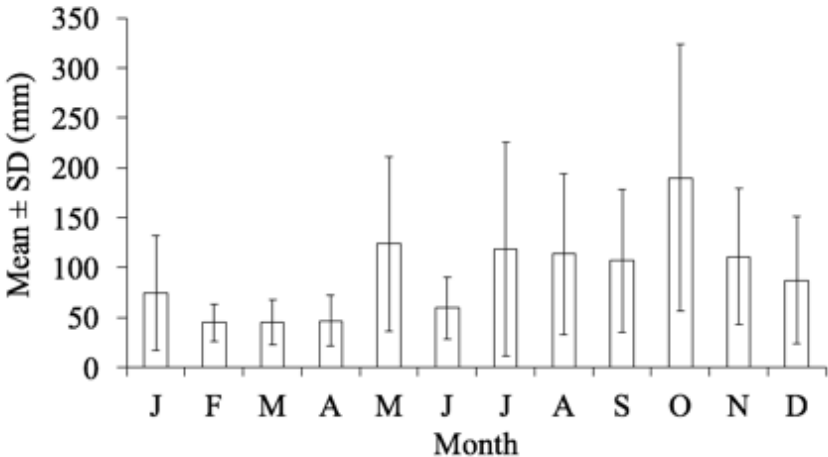
The Camp is located at a low-lying altitude and is thus likely to receive less rainfall than the higher elevations of the Quill and Boven mountains. The dry season typically runs from January to April, with rainy season occurring during the second half of the year, which coincides with the hurricane season (Figure 7). To avoid potential loss of topsoil and prevent soil eroding into the waters below, it is not recommended to leave large areas of bare ground exposed during this time. In addition, most of the vegetation that exists in this area is native and serves a variety of ecological purposes. Removing this vegetation will increase the risk of run-off into the marine environment.

Figure 7: Average monthly rainfall on St. Eustatius (source: <http://seawf.com/rainhist.php>).
